Edison Wetlands Association, Inc.

Site Inspection Report

Cornell Dubilier Superfund Site
333 Hamilton Boulevard
South Plainfield, NJ
Middlesex County

Inspection Date: September 9, 1999 Report Issued: September 30, 1999

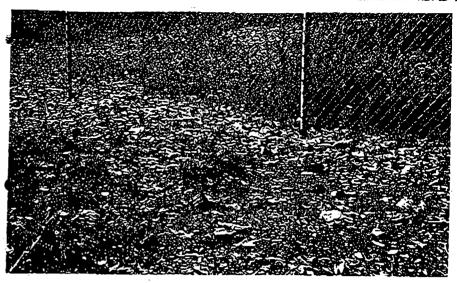
Warning sign at the
Perimeter of the Cornell
Dubilier Superfund Site.

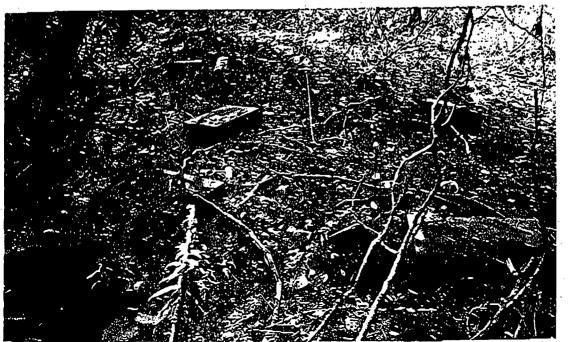
Leaking PCB capacitor in the Dismal Swamp, South Plainfield, NJ.

- 3. Designate the Dismal Swamp dumping area containing PCB-contaminated capacitors as an operable unit of the Cornell Dubilier site and immediately delineate the extent of soil, water, and biota impacts of this area (see Attachment A-4).

- 4. EWA recommends that the EPA investigates the area and conducts a removal action of the capacitors and surrounding soil.
- 5. Extend the fence line at the site to encompass the entire area along Spice Avenue (beyond the property owner boundary) until such time that EPA can sample the area and prove that contamination stops at the property line.

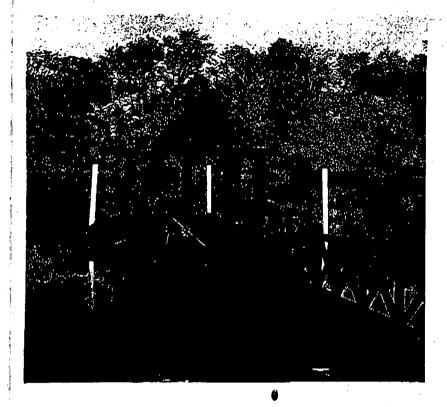
Spiegel then went to New Market Pond and observed that the "Fishing Advisory" signs had been removed. He also observed several fishermen at the pond. Spiegel discussed the advisory with the gentlemen and was told that the Carp caught were being consumed and that they thought the pond was cleaned up since the signs were no longer posted.

Subsistence fisherman at New Market Pond. *Note that there are no fish advisory signs in the area.

- 8. Implement hot-spot removal for PCB's in the Bound Brook above 25 PPM.
- 9. Install additional signs in the New Market Pond so that subsistence fisherman will be aware of contamination in the fish and pond.

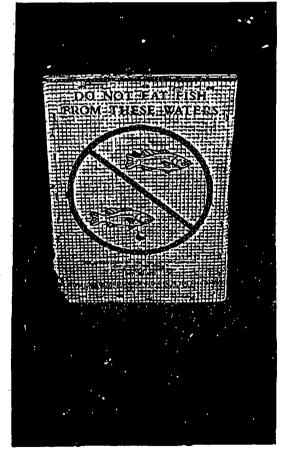
Last remaining advisory sign around New Market Pond. The sign is located in a remote area and does not appear near popular fishing locations.
